NASA CR-159600
VOLUME 1 OF 2
AIRESEARCH 21-3213-1

MATERIALS FOR ADVANCED TURBINE ENGINES

PROJECT COMPLETION REPORT PROJECT 2

ABRADABLE COMPRESSOR AND TURBINE SEALS

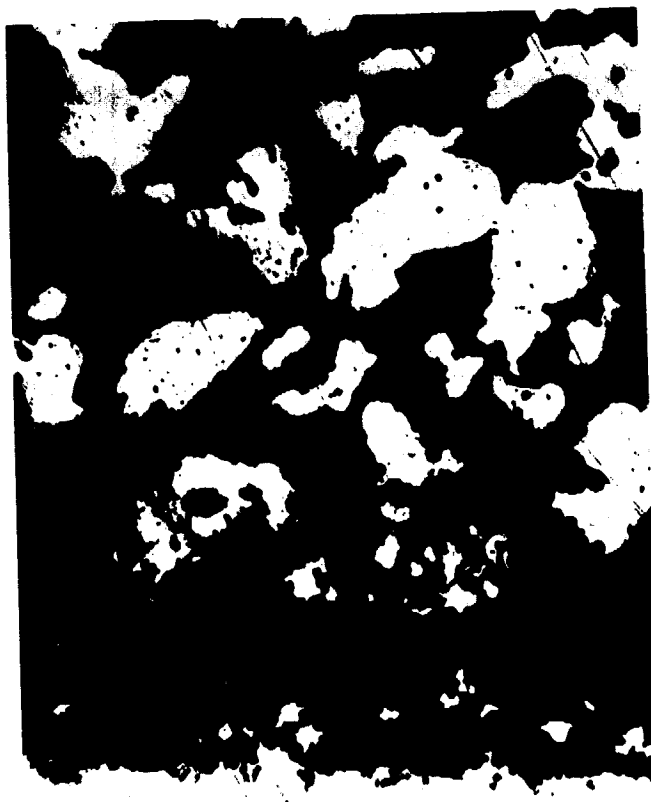
Figure 23. Microstructure Showing Failure Region of the
Brazed Joint in a High-Pressure Turbine Shroud
Segment After 370 Hours at 1323°K (1922°F)
(Mag.: 100X)

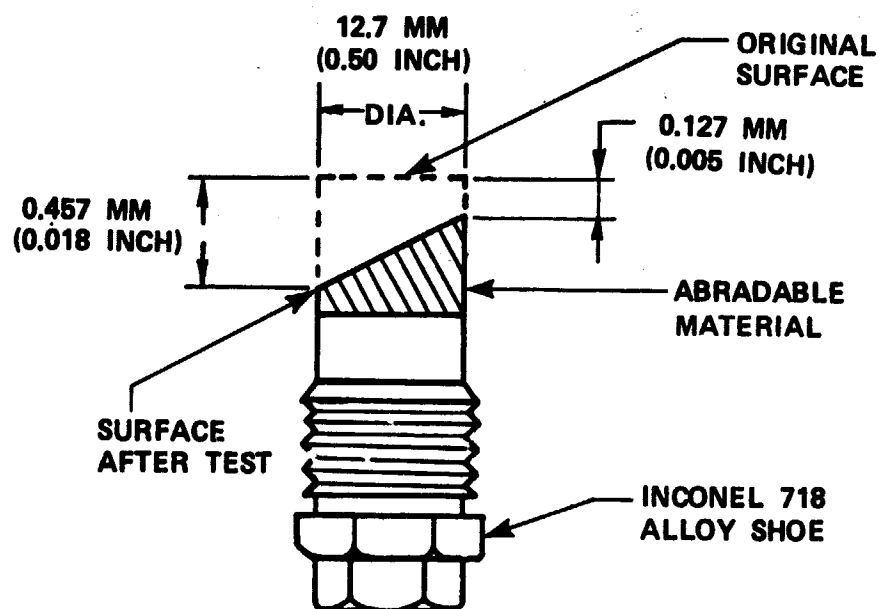
Figure 31. Typical Wear Contour on High-Pressure Compressor Test Shoes after One Hour of Engine Testing

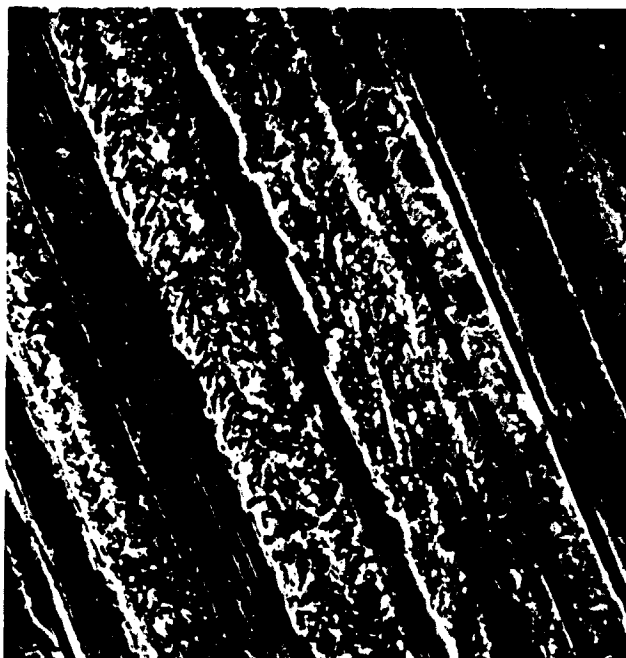
Figure 37. Scanning Electron Microscope Image of a Metco SF Rub Surface After One Hour of Engine Testing (Mag.: 500X)

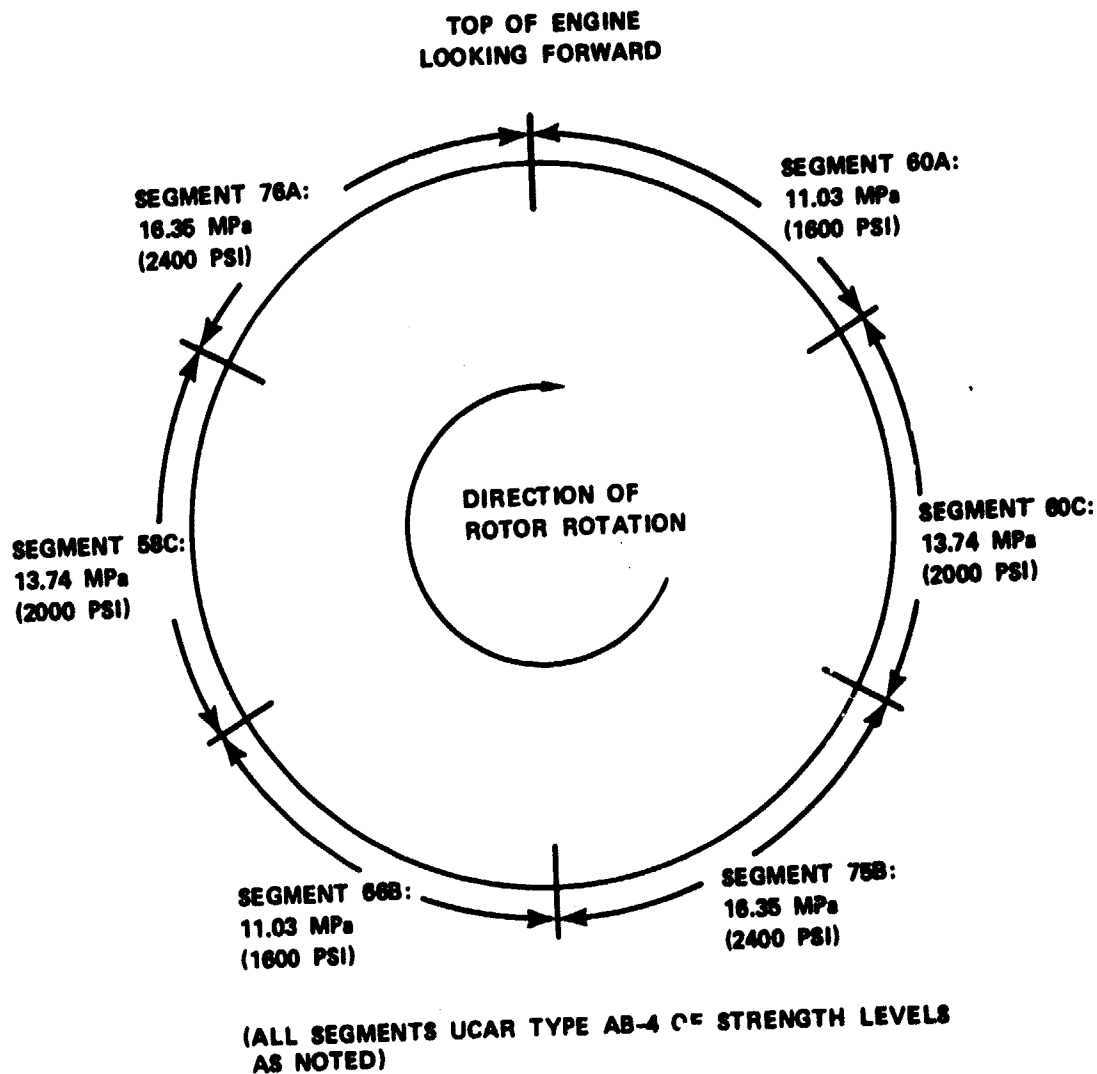
POSITION	SEGMENT AND GROOVE DEPTH-OF-WEAR [mm (INCHES)]					
	58C	60C	66B	60A	75B	76A
LEADING EDGE	NOT MEASURED	0.203 (0.008)	0.305 (0.012)	0.076 (0.003)	0.457 (0.018)	0.000 (0.000)
TRAILING EDGE	NOT MEASURED	0.432 (0.017)	0.432 (0.017)	0.305 (0.012)	0.432 (0.017)	0.102 (0.004)

c. UCAR AB-4, 16.35 MPa (2400-psi) strength level-
Segment 75B, 16.35 MPa (2400 psi) material, exhibited 0.457 mm (0.018 inch) of wear in the deepest groove and a large smear area. Figure 42 presents the smeared surface as examined under the optical microscope and the SEM. X-ray analysis disclosed that the surface of the smear region was

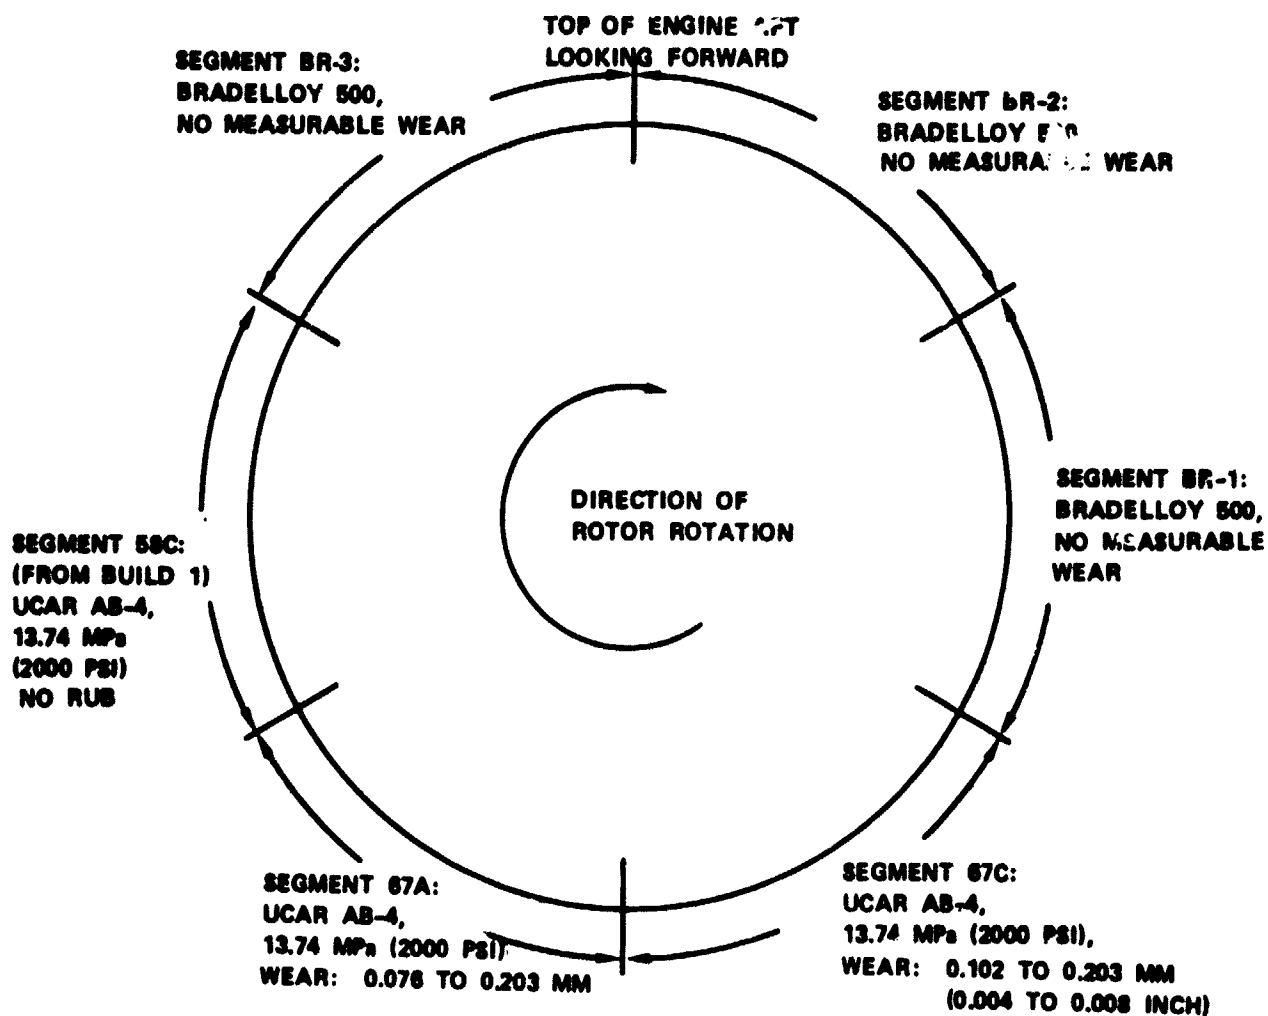
Figure 49. Schematic of the First Interim Engine Test (Build 2) High-Pressure Turbine Shroud Segment Locations Showing Material Identification and Measured Groove Depth-of-Wear

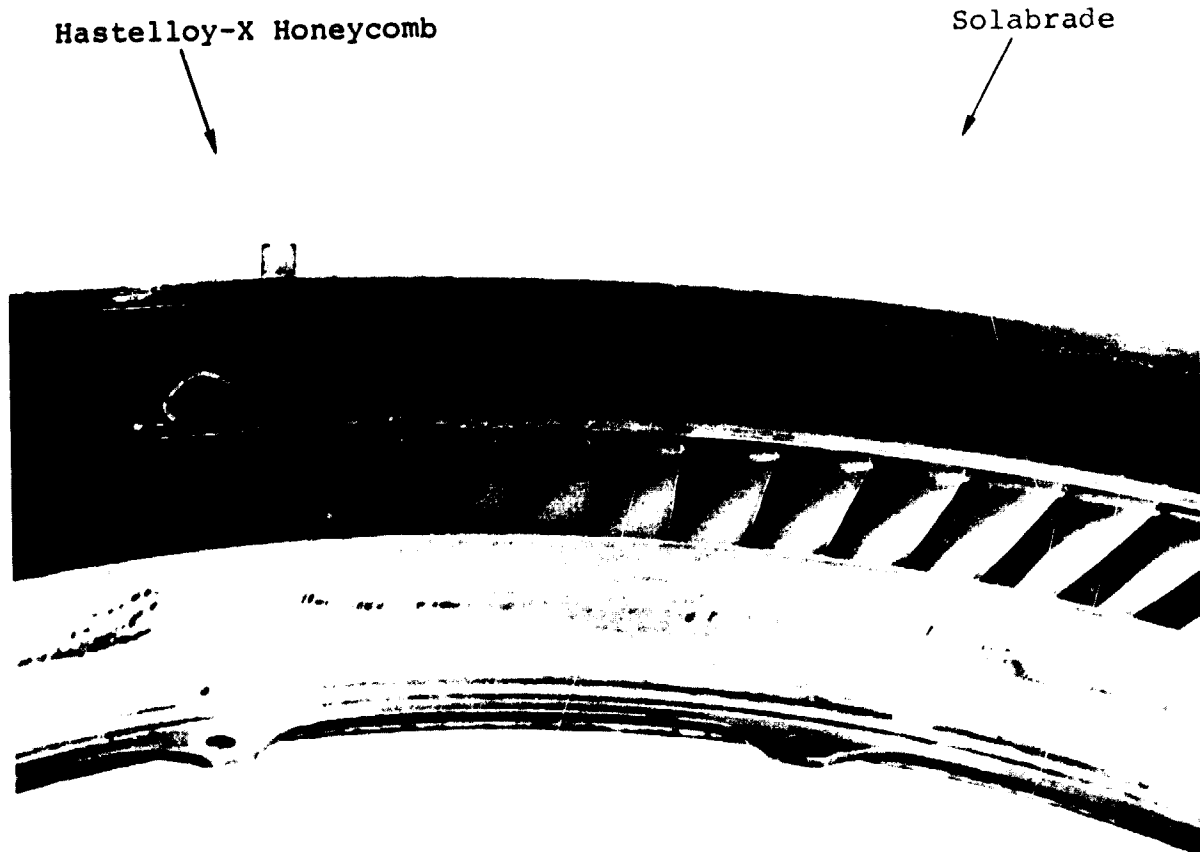
Figure 76. Appearance of First-Stage Low-Pressure Turbine Shroud Containing Hastelloy-X and Solabrade After 25 Hours of the Second Interim Engine Test, Build 3 (Mag.: 1/2X)

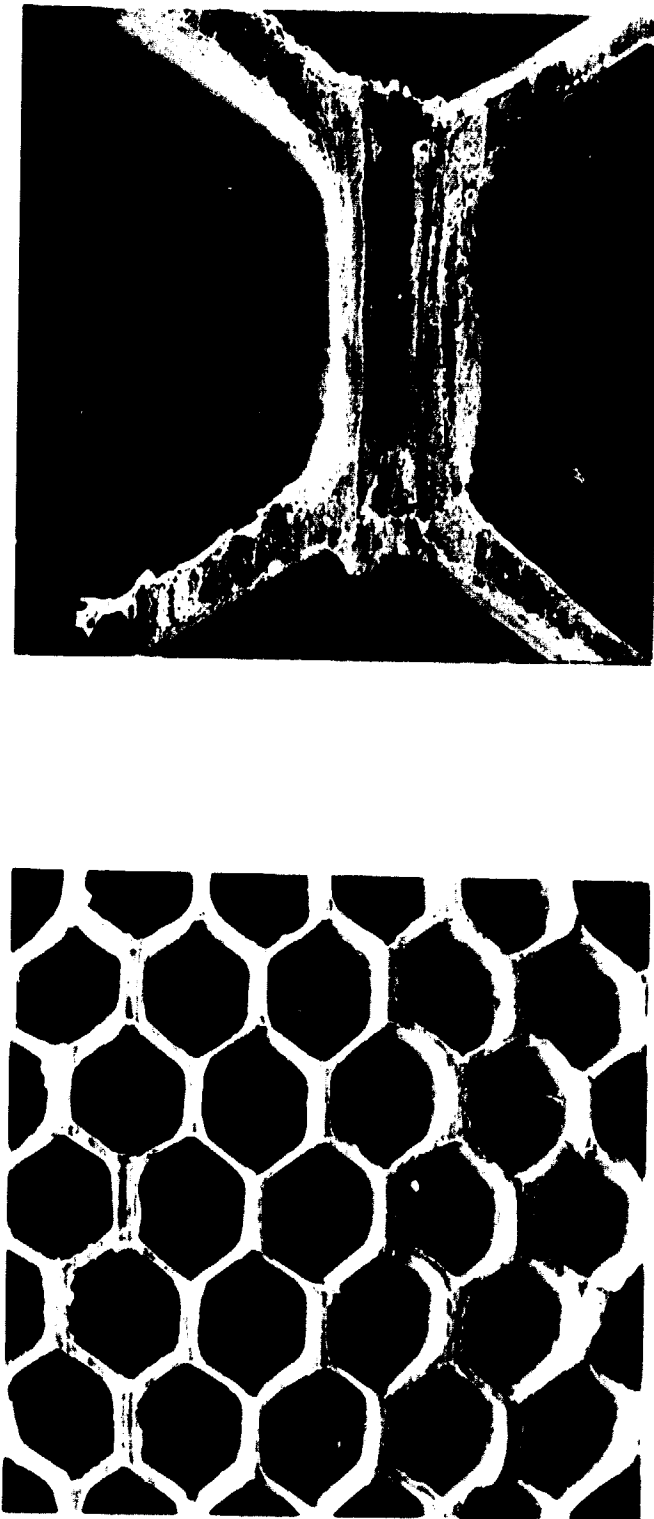
Figure 77. Appearance of Hastelloy-X First-Stage Low-Pressure Turbine
Shroud After 25 Hours of the Second Interim Engine Test,
Build 3

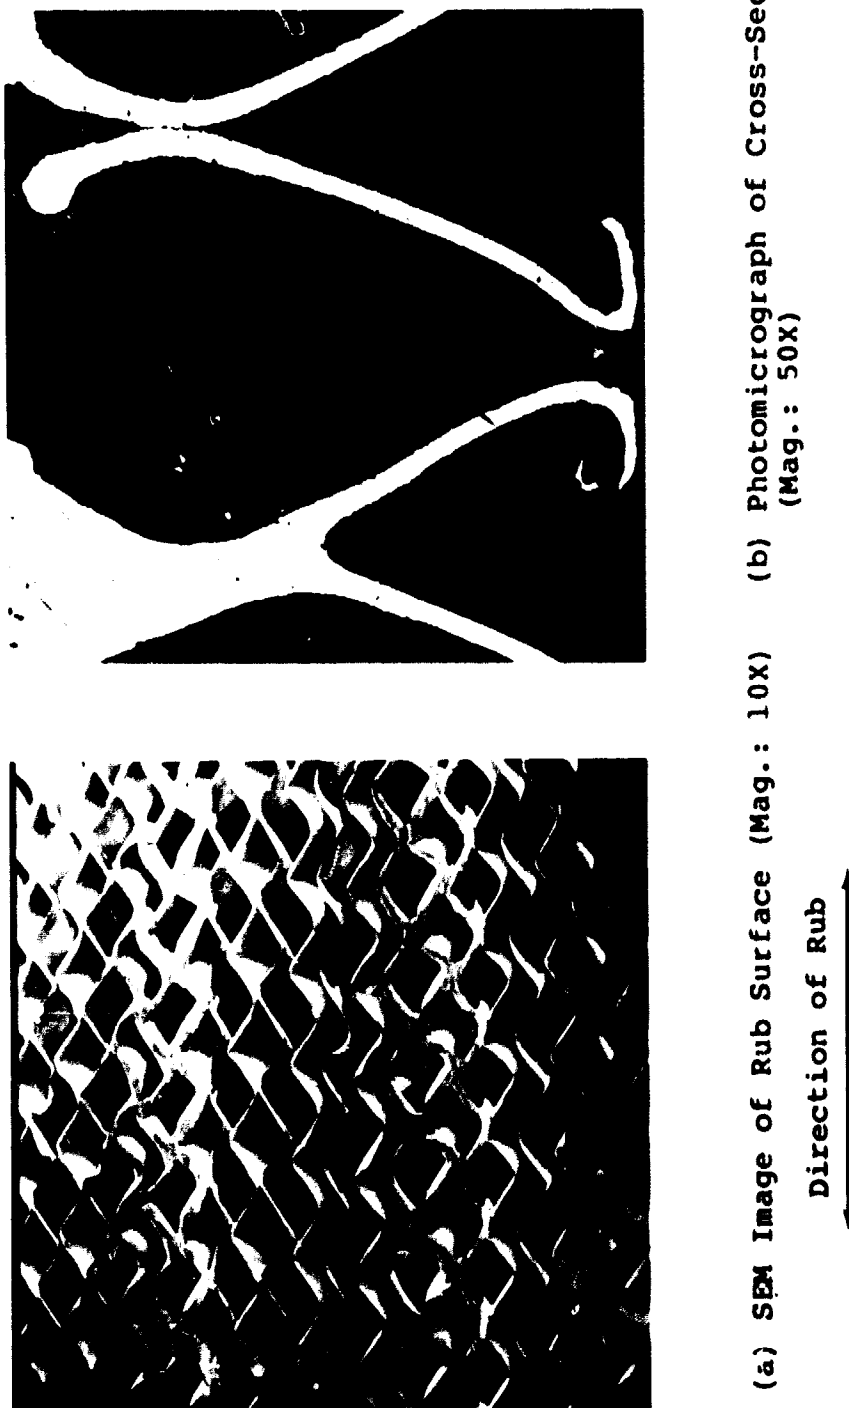
Figure 78. Appearance of Solabrade First-Stage Low-Pressure Turbine Shroud After 25 Hours of the Second Interim Engine Test, Build 3

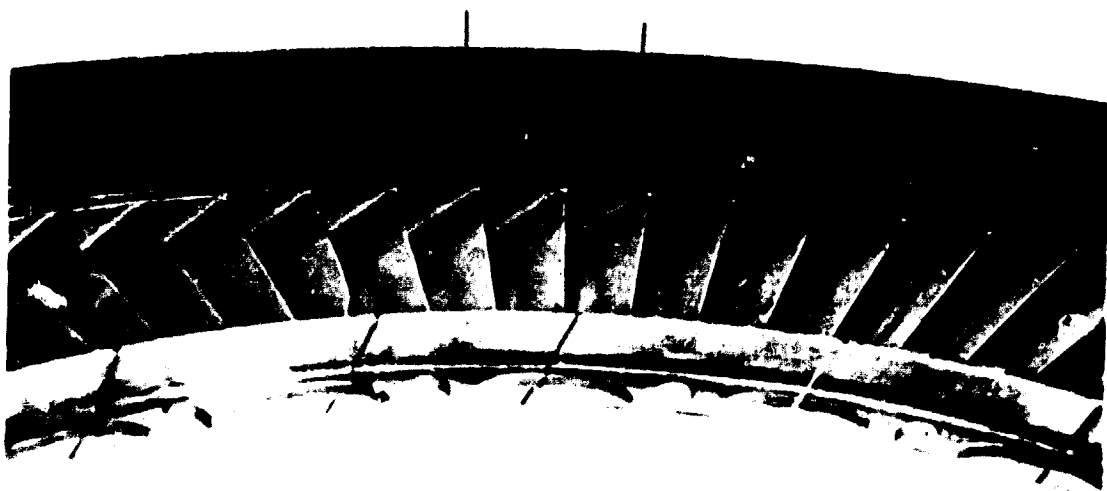
Pull-out from under the wear track

Figure 79. Appearance of Metco T301-10 Second-Stage Low-Pressure Turbine Shroud After 25 Hours of the Second Interim Engine Test, Build 3 (Mag.: 1/2X)
